COPIES	DATE	NO.	DESCRIPTION
2	March 1989		Work Plan, Offsite Drainage Ditch Stabilization NVF Company, Kennett Square Facility

## 1.0 BACKGROUND

## 2.0 DITCH STABILIZATION PLAN

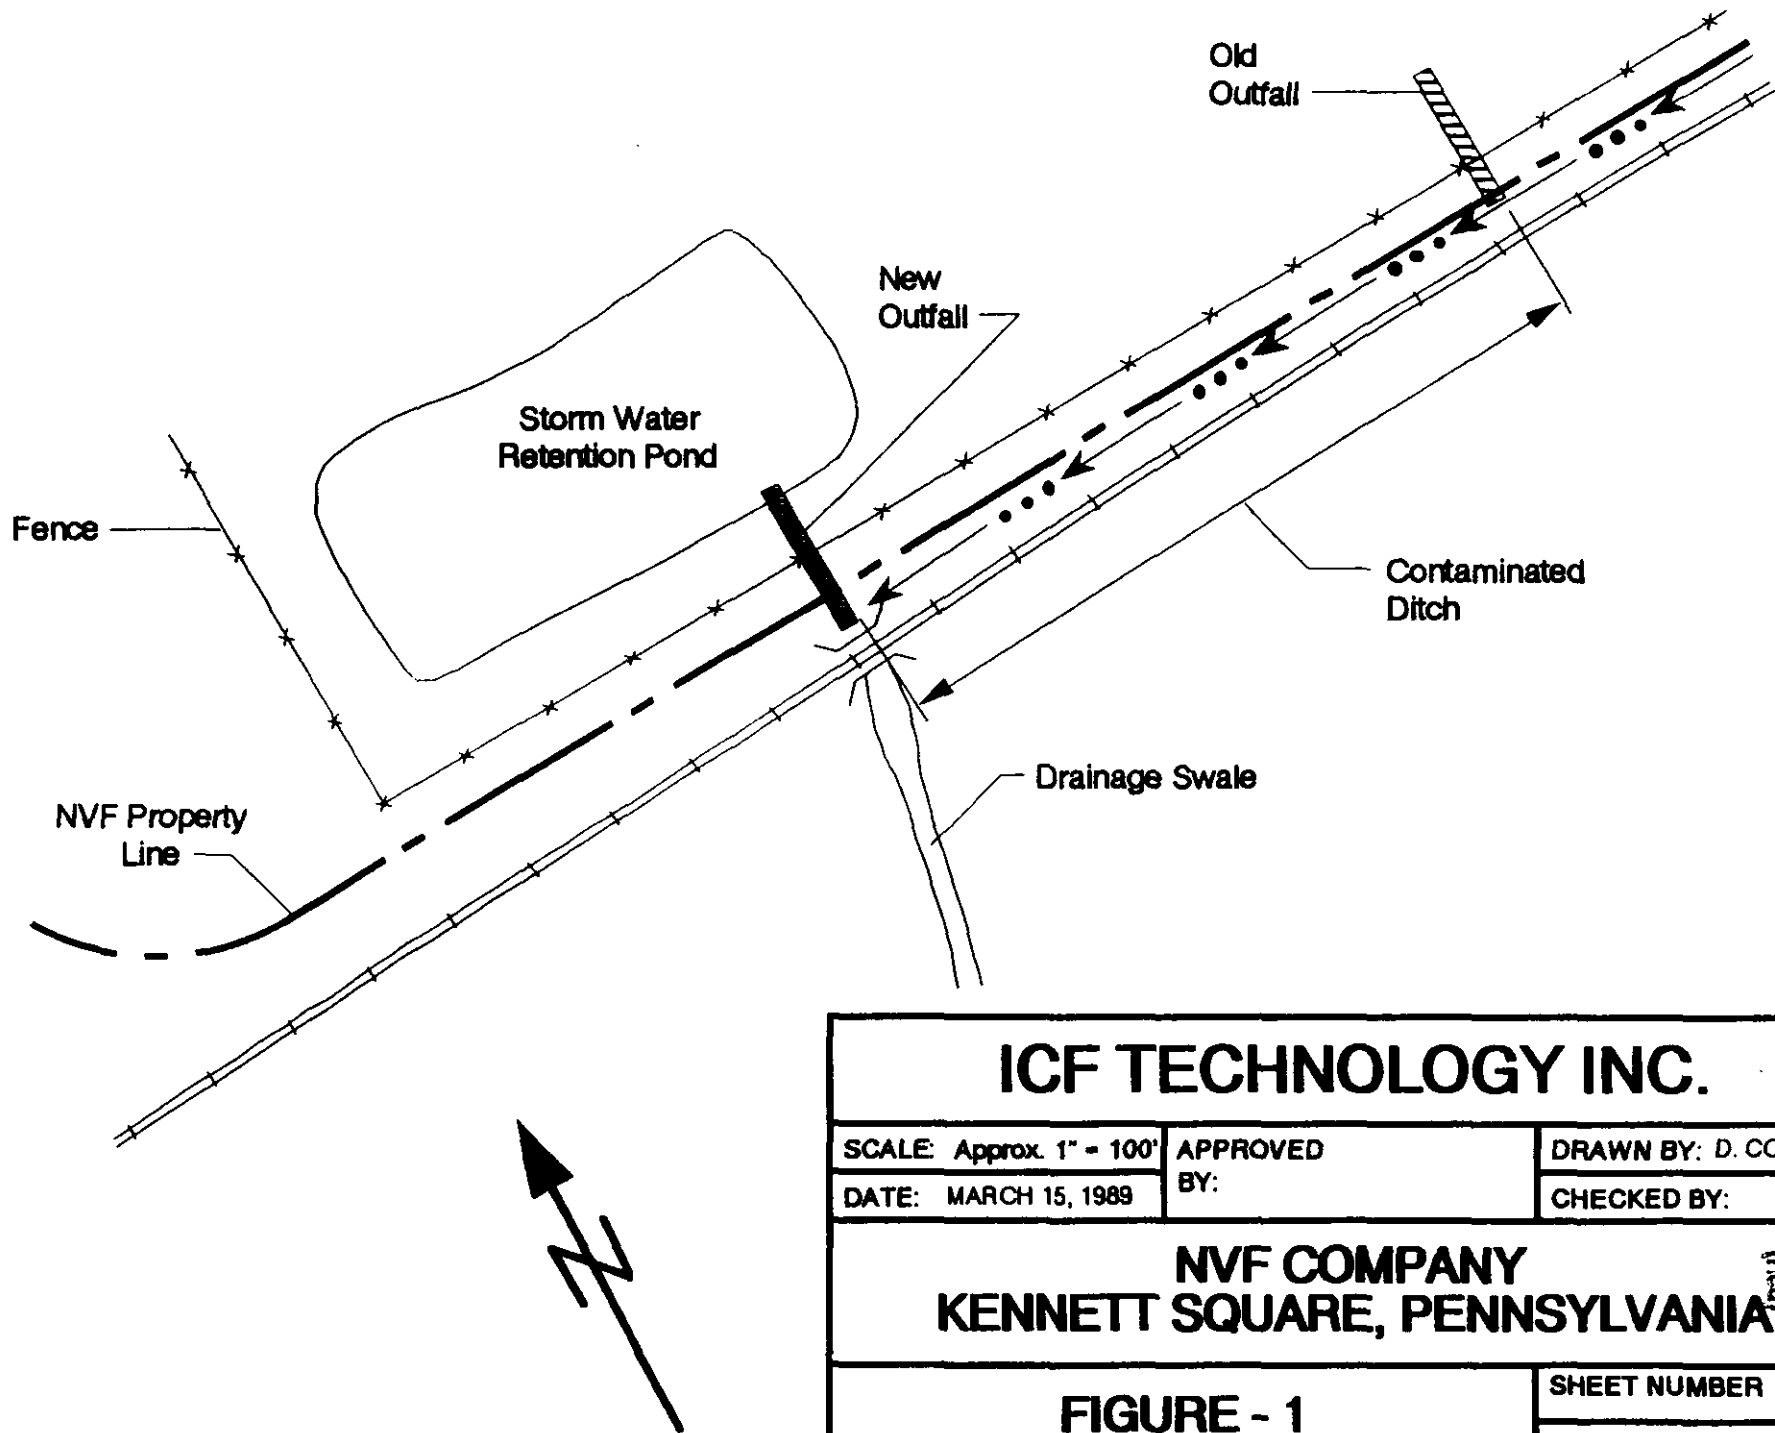
**FIGURE - 1**  
**SITE PLAN**

The proposed liner/cap system would extend along the length of the ditch (approximately 400 feet) from the old outfall to the new outfall, as shown on Figure 1. Laterally, the liner/cap would extend from the NVF fence line across the ditch and up the railroad embankment on the other side of the ditch. The proposed configuration will cap the ditch area adjacent to the NVF facility between NVF's old outfall and the new outfall (See Figure 1).

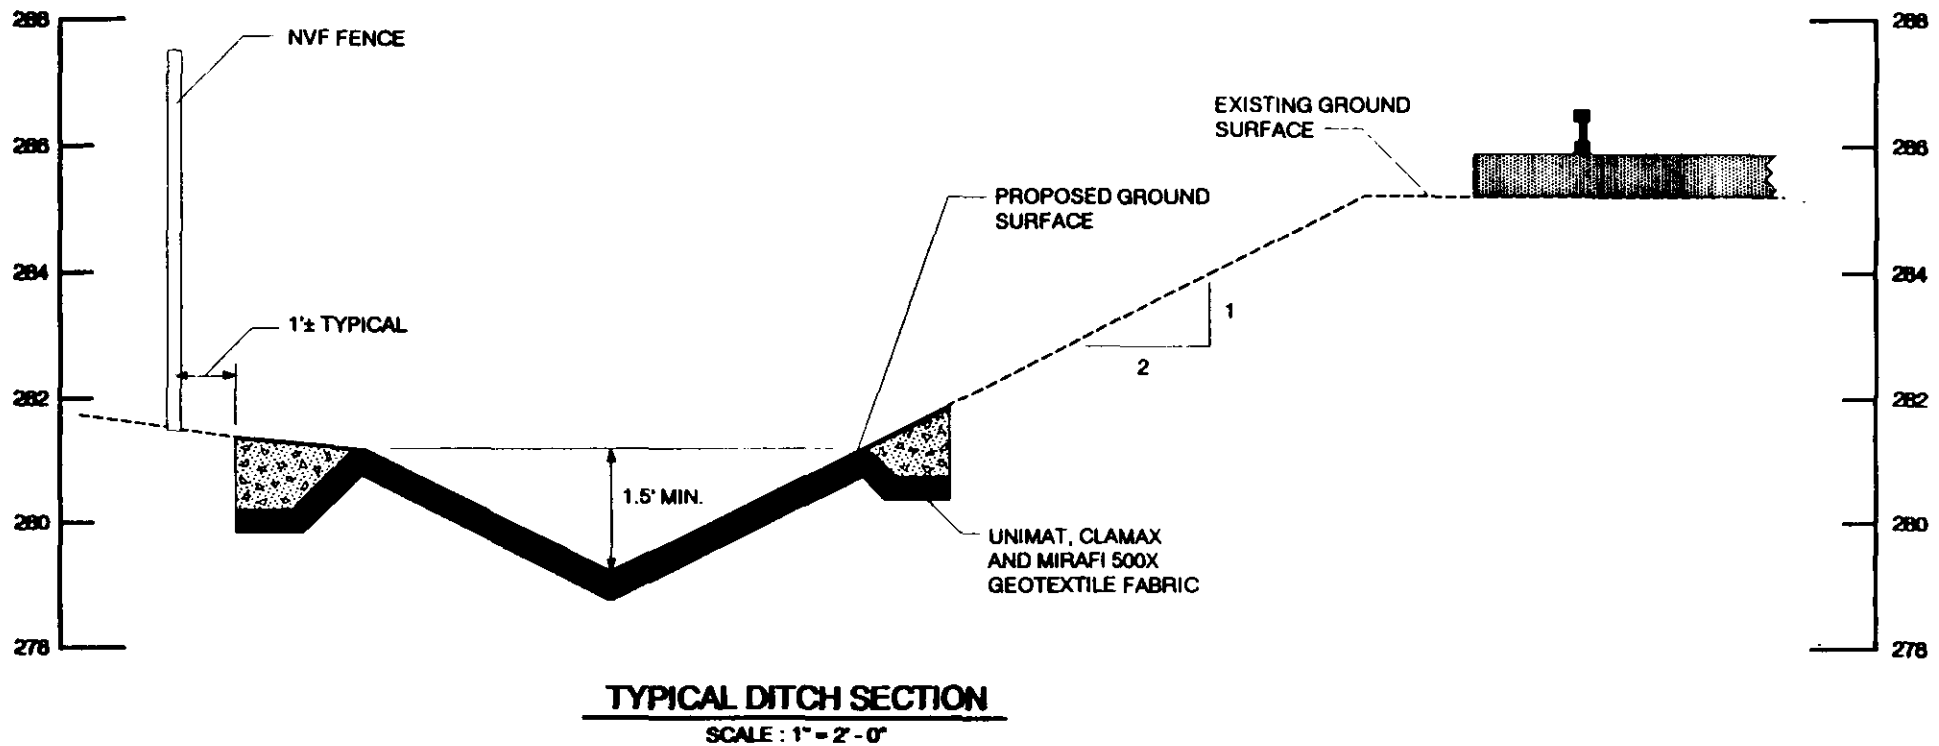
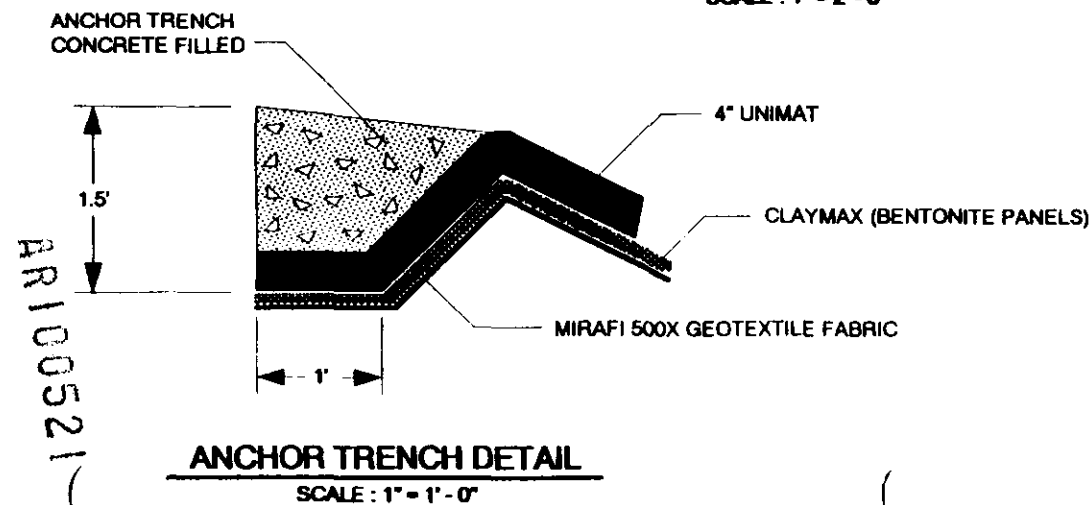
<b>ICF TECHNOLOGY INC.</b>		
SCALE: As Shown	APPROVED BY:	DRAWN BY: D. COULTER
DATE: MARCH 15, 1989	CHECKED BY:	
<b>NVF COMPANY</b> <b>KENNETT SQUARE, PENNSYLVANIA</b>		
<b>FIGURE - 2</b> <b>TYPICAL SECTION</b>		SHEET NUMBER 1 of 1
		DRAWING NUMBER 30160-1

The liner/cap system would consist of three components. These include a layer of a geotextile fabric (Mirafi 500X); a commercially manufactured composite liner material (Claymax), which has been designed for hazardous waste landfill applications; and an overlying concrete "cap" to protect the liner and prevent erosion. The concrete cap will consist of a 4-inch-thick commercially manufactured fabric "form" (Fabriform Unimat) filled with a cement-based

grout. This material is designed to prevent stream and beach erosion, and is widely used in this type of application. A cross section of the liner/cap system is presented in Figure 2.

The Fabriform Unimat system consists of porous woven synthetic fabric forms into which a concrete-based grout is injected to form a strong, durable, crack resistant four-inch thick concrete blanket. The fabric is immune to attack by acids, alkalis, organic solvents, and biological agents. A mixture of one percent noncorrosive polypropylene fibers will be added to the grout to reinforce the grout and minimize shrinkage and cracking during curing.

Once in place, cement grout will be pumped into the Unimat, forming a continuous, four-inch thick durable lining. The water in the grout mix will wet the underlying Claymax, causing the bentonite to expand. The grout will be a sand-cement mixture with five to eight percent entrained air and approximately one percent noncorrosive polypropylene fibers. The described additives provide for increased freeze/thaw durability and minimize shrinkage cracking during curing. The perimeter anchor trenches will also be backfilled with cement grout.
